SKF engineering solutions applied to pulp & paper mill

Rodrigo Yoshiaki Fujimoto* and Hilário Jacob Sinkoc*

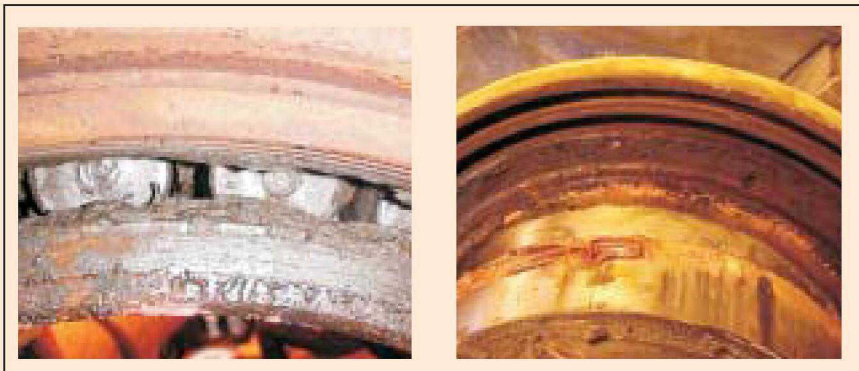
Figure 1 - Detail of rolling bearing with degraded grease because of water contamination.

Among the main problems of rolls installed in the wet section of paper machines, the main problem is the contamination of bearing and lubricant by water. This contamination produces lubrication failure with breakage of lubrication film and corrosion of rolling bearing raceways. Because of these failures caused by water contamination, we can point to water contamination as the main concern of rolls installed in this section.

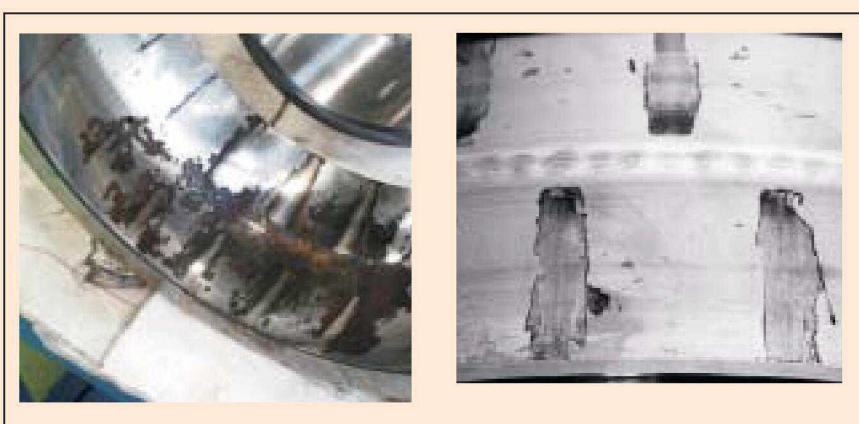
Figure 2 - Detail of rolling bearing raceways with corrosion from water contamination.

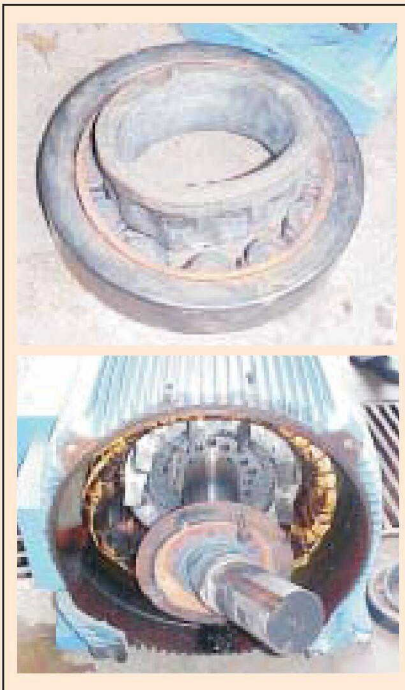
Figure 6 - Detail of damage of rolling bearing and shaft because of high temperature condition.

The first failure observed on field was an overheating of bearing shaft/housing that caused severe damage to these components. In this specific case, the motor drives a centrifugal pump through coupling. The standard configuration of this motor (frame 355 M/L) uses a cylindrical roller bearing at coupling side (NU 322 C3) and a deep groove ball bearing at opposite side (6319 C3). This is the ideal configuration for transmission of power by belt.

Through failure analyses, we discovered that the failure cause was smearing (sliding of rolling element in entry of load zone of raceway) originated by low radial minimum load. Usually, this failure is observed in motors that use coupling. In addition, this problem is aggravated by other application characteristics (e.g. high lubricant oil viscosity, among others).

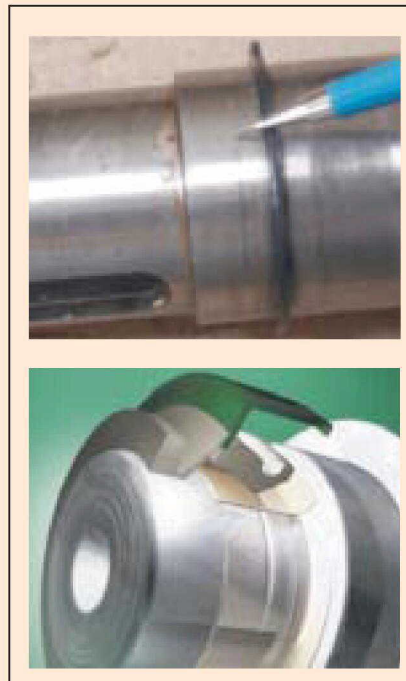
Figure 10 - Example of shaft wear on the contact with shaft seal lip. The scheme of mounting of wear sleeve is also shown.

However, after a long time of work, the shaft will wear on the contact with the shaft seal lip, resulting in deficient sealing. In this case, we recommend using a wear sleeve Speedi-Sleeve (CR Seal Handbook - Size and Type Listings for all Seal Applications).

This wear sleeve corrects the shaft wear; and it avoids the wear forming in new shaft.
